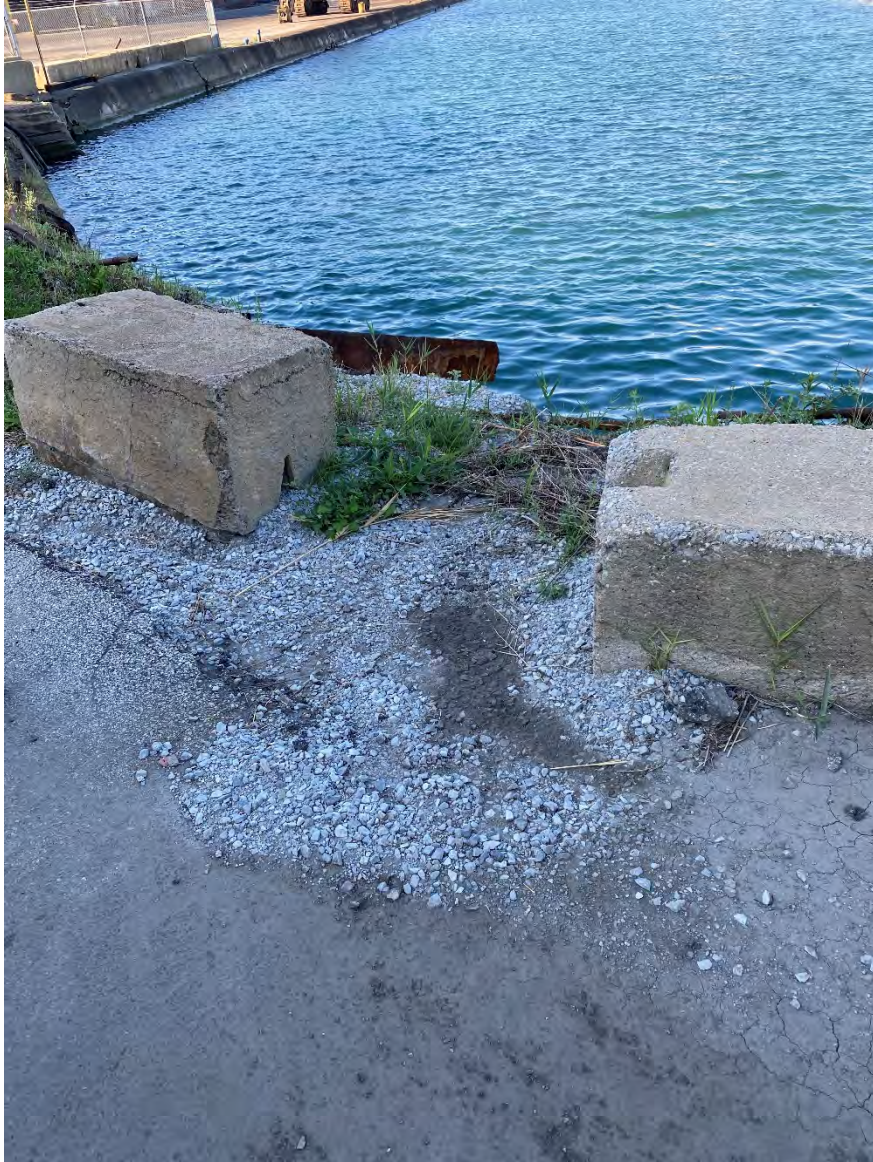
Photo 1: Identified Drainage 001 location, as referenced in SWPPP. Currently dry weather, no runoff occurring into River.

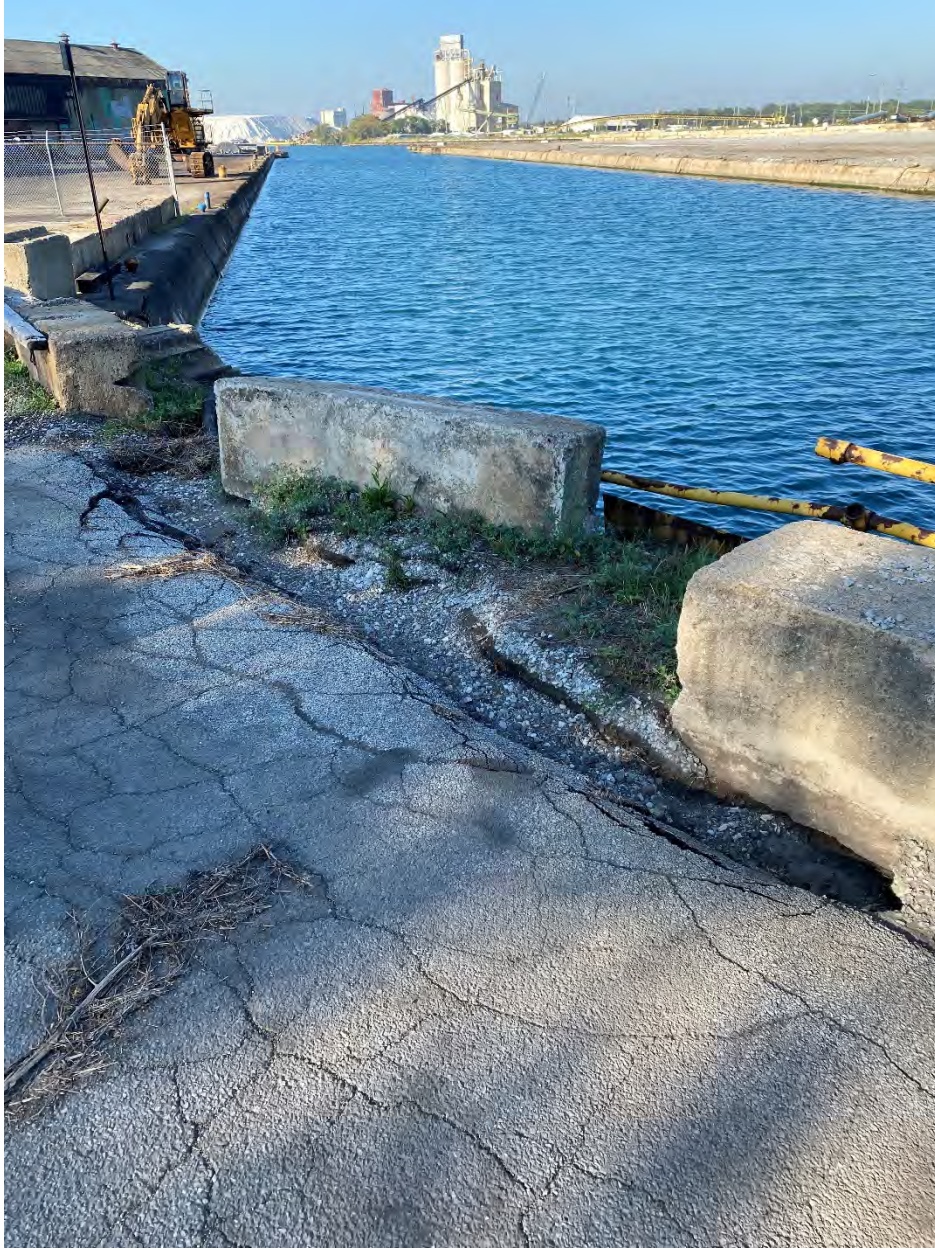
Photo 2: Identified Drainage 001 location, as referenced in SWPPP. Currently dry weather, no runoff occurring into River.

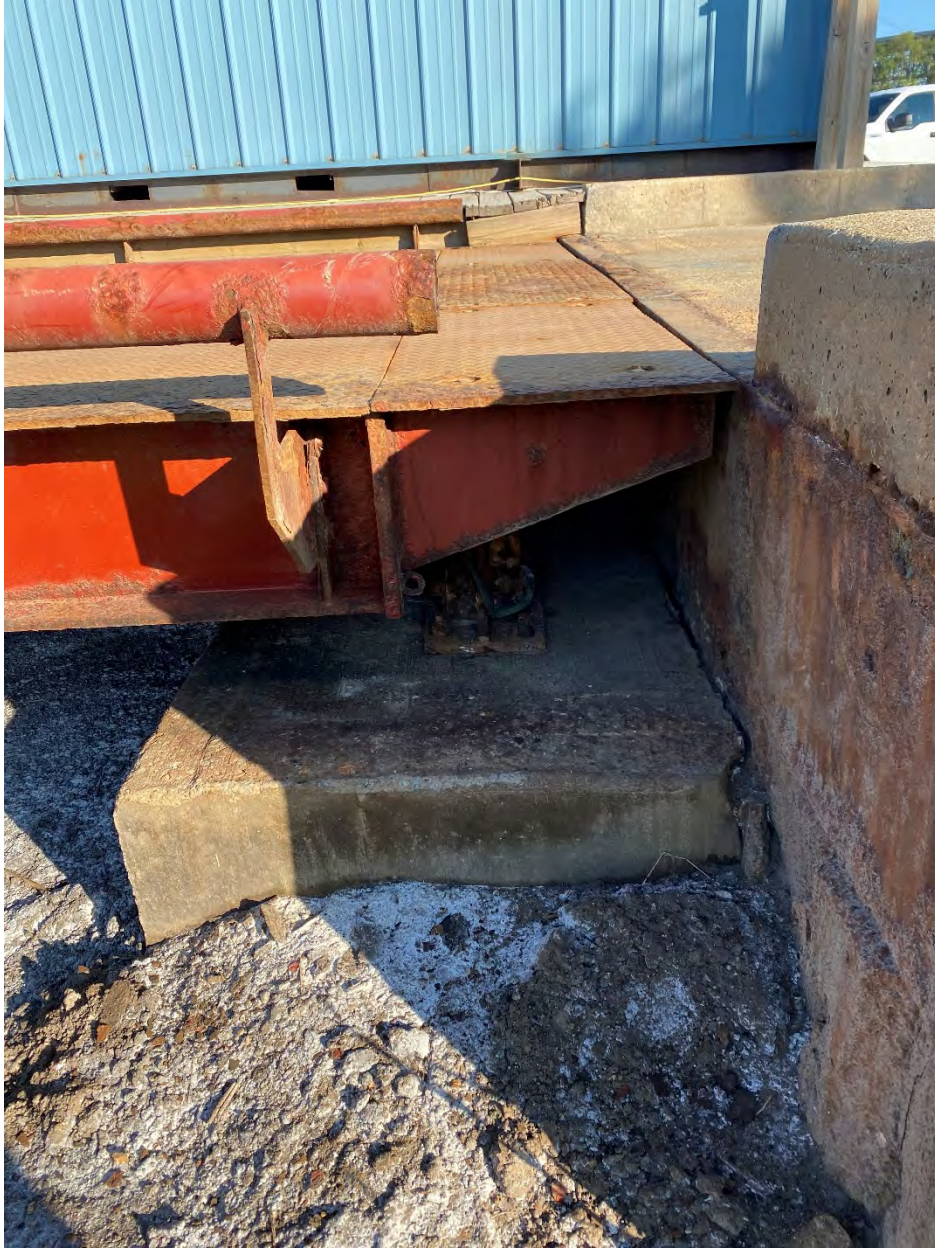
Photo 3: Area under scale. Salt deposits occur over time as trucks drive over, and residue from tires drips below to the shown area. Morton Salt has cleaned up the area recently, and intend to put a rubber cover to prevent the deposits from continuing to occur.

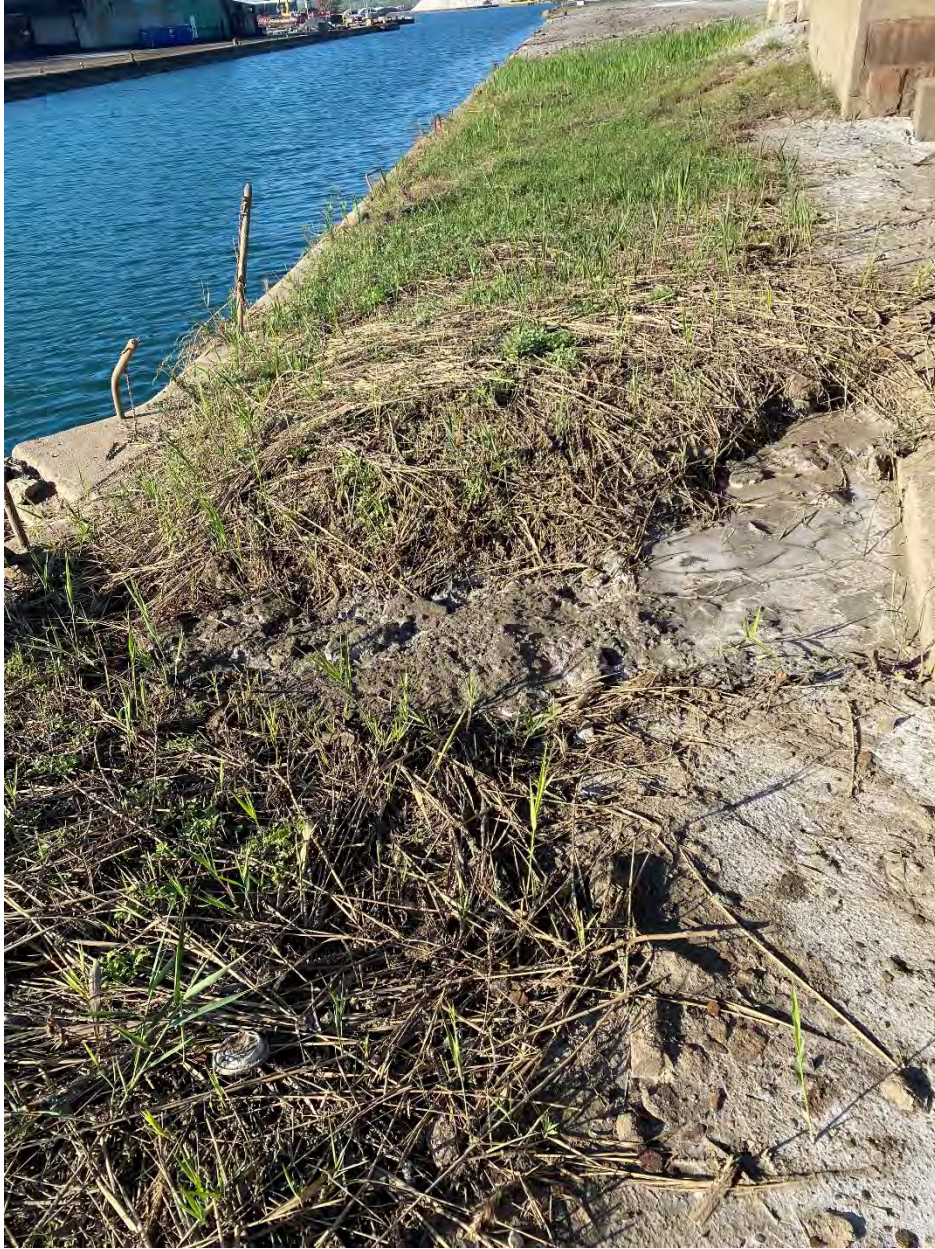
Photo 4: Identified Drainage 001 location, as referenced in SWPPP. Currently dry weather, no runoff occurring into River.

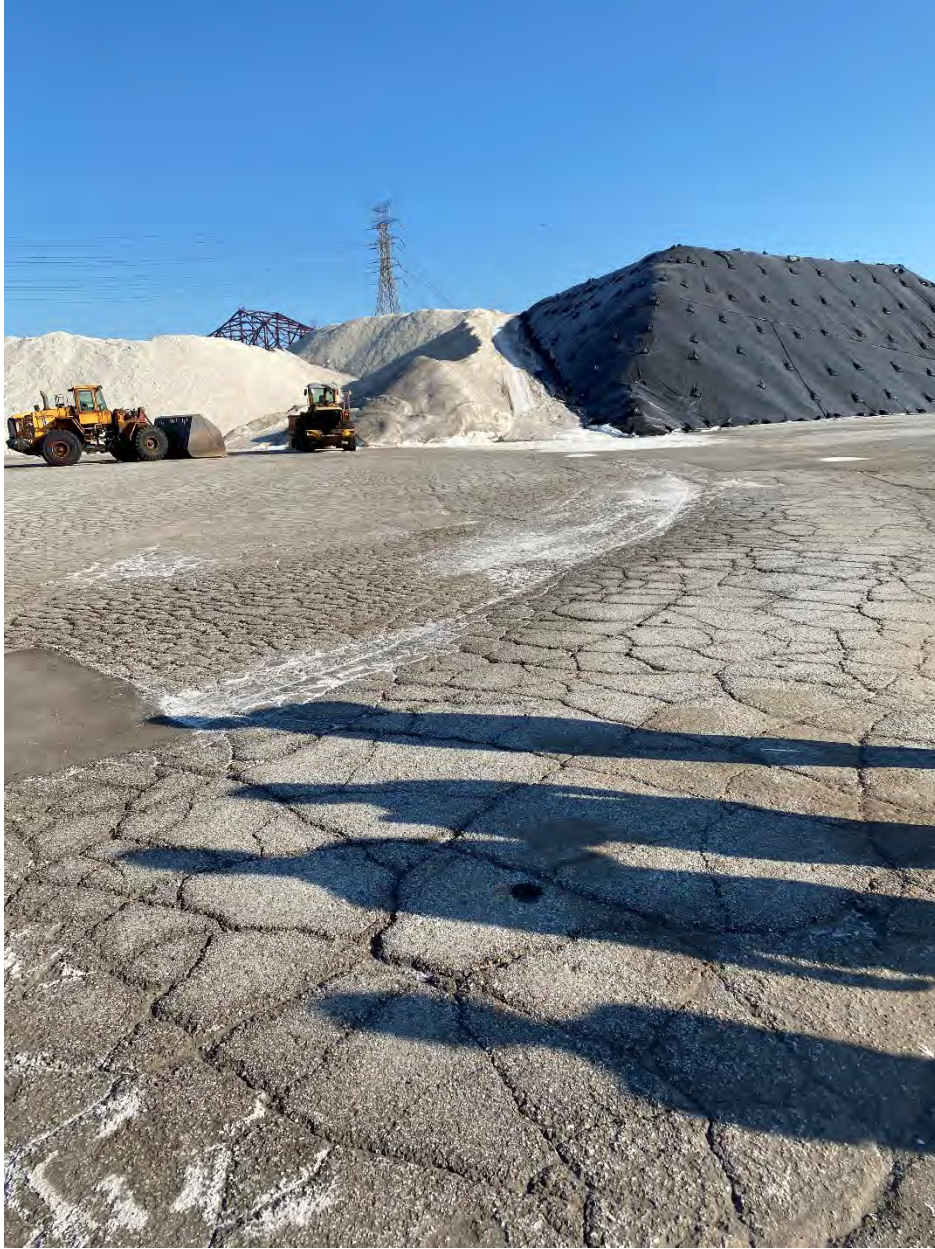
Photo 5: Area that gets runoff from salt pile during storm event.

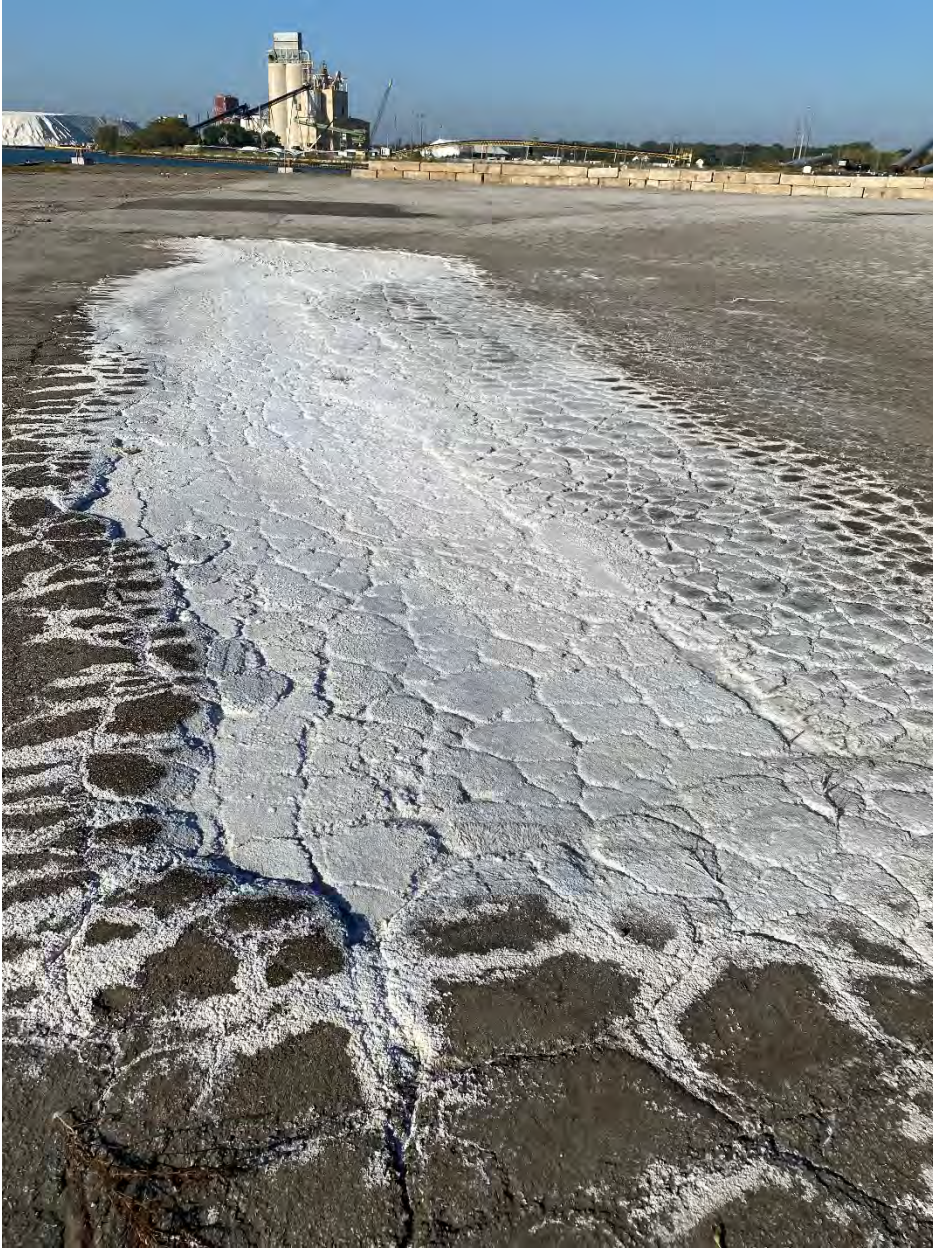
Photo 6: Area that gets runoff from salt pile during storm event.

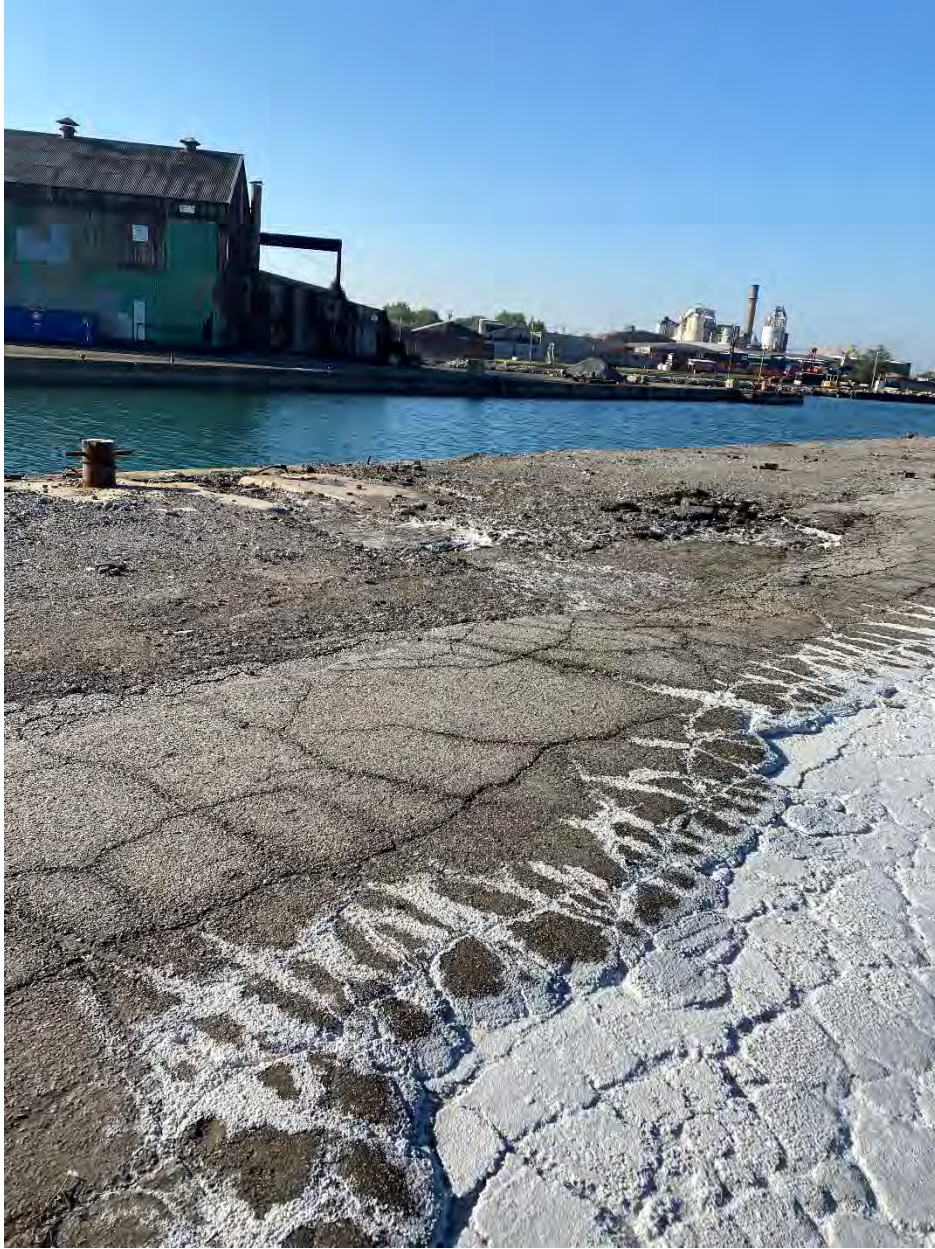
Photo 7: Area that gets runoff from salt pile during storm event. Identified as Discharge 002 in SWPPP.

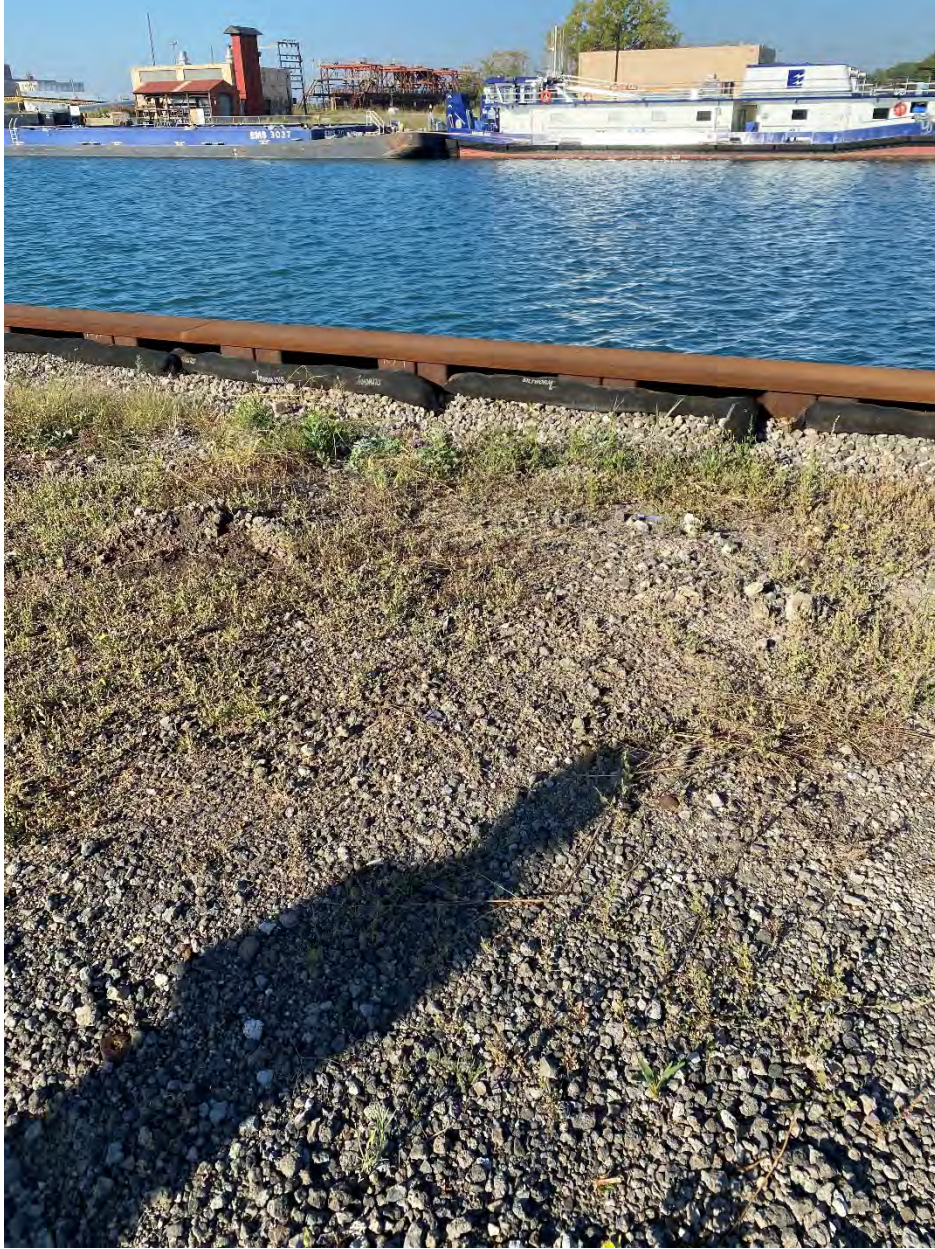
Photo 8: Area that was affected from a recent vessel. Morton Salt cleaned up affected area and filled with dirt.

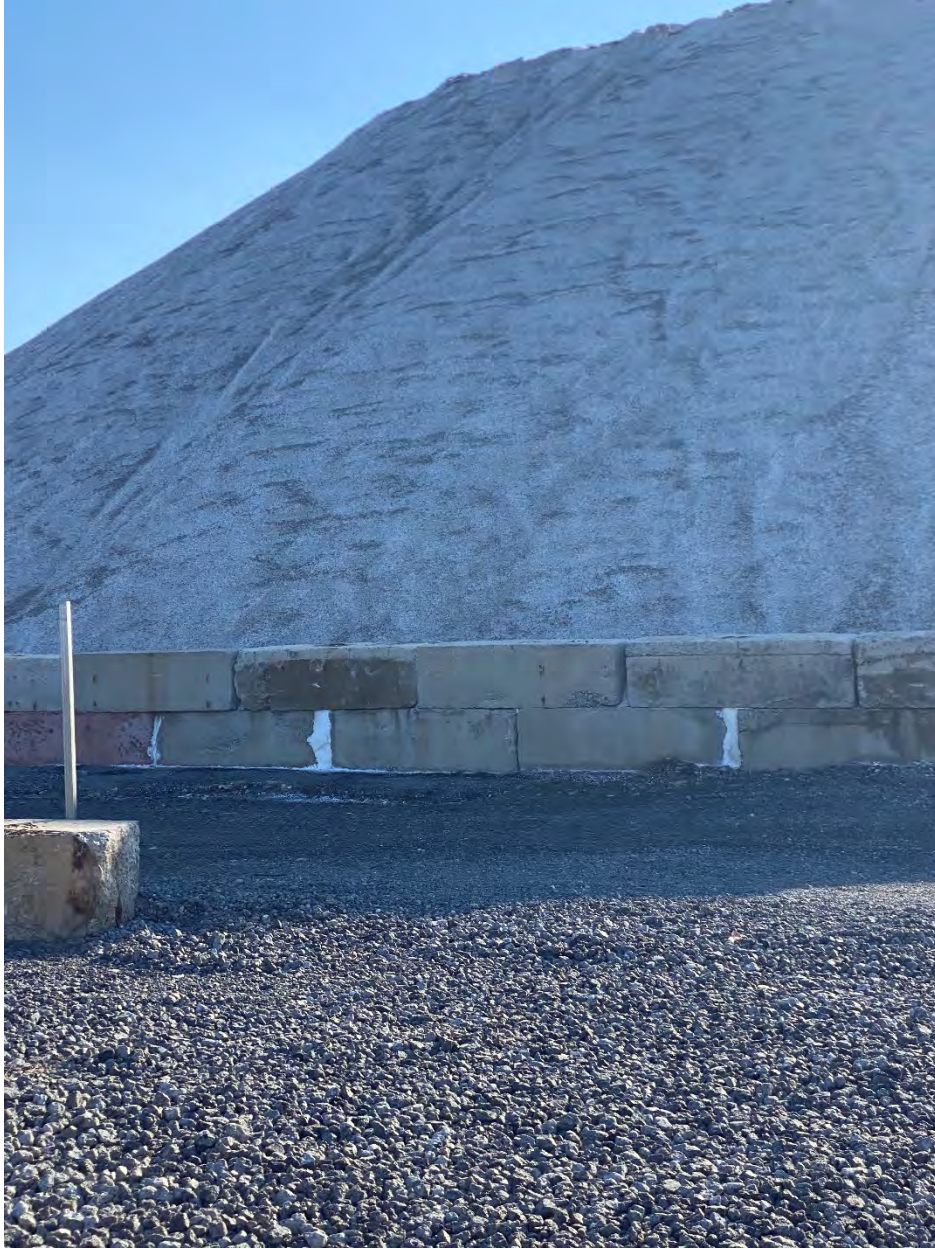
Photo 9: Salt pile retaining wall. Some salt seeps through the cracks, but Morton Salt maintains the area by cleaning.

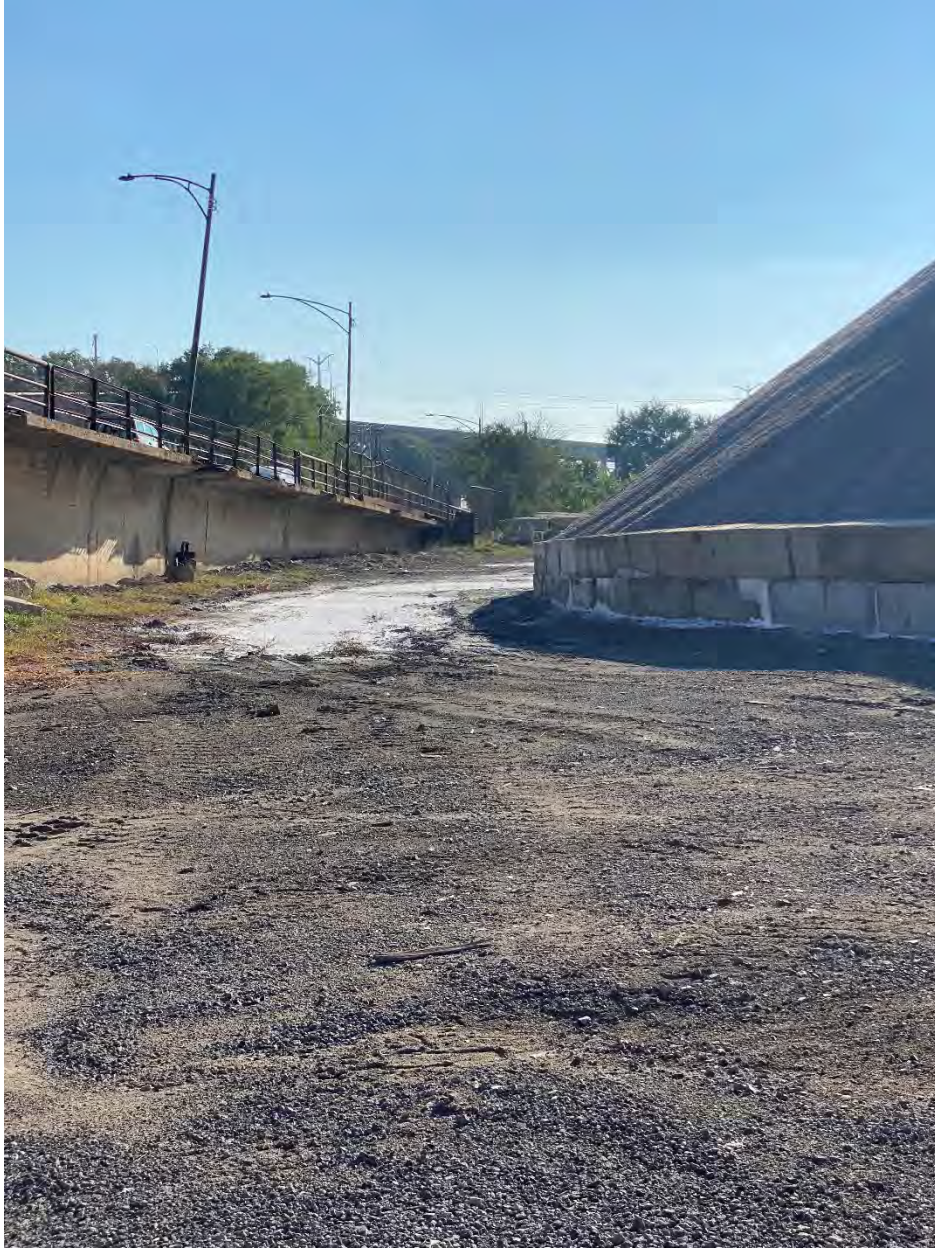
Photo 10: Salt pile retaining wall. Some salt seeps through the cracks, but Morton Salt maintains the area by cleaning. Area to the left of the retaining well receives runoff during storm event, but it does not discharge to the River.
